**Flood Control Project Maintenance
Levee Inspections**

Fall 2018 Levee Maintenance Deficiency Summary Report

Sacramento River Basin

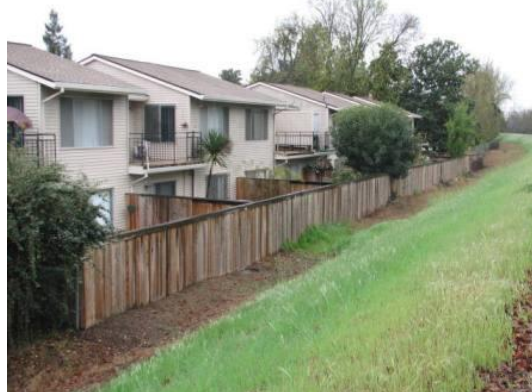
Photo 1 of 1 : FA_2018_NA0001_55_74_20180911_00061.jpg

LM Start	7.65	Rating **	U	Issue No.	74
LM End	7.68	Issue Type +	En	Location *	LS
Category	Earthen Levee			GPS Latitude/Longitude	
				Start	End
Item	Encroachments			38.559177 °	38.559218 °
				-121.403541 °	-121.402967 °
DWR ID	DWR_NA0001_04_s_2012_74				
Comment Code					
FE : Fence					
Inspector Comment					
Wooden privacy fence for seven apartment units is within 10-ft of levee toe and obstructs access and visibility.

03/16/2012 Wood privacy fence completely obstructs access and visibility.

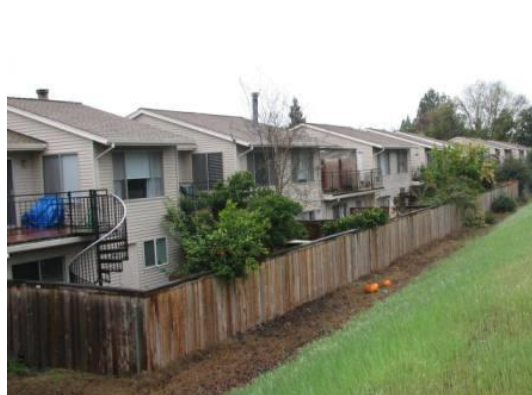
Photo 1 of 1 : FA_2018_NA0001_55_75_20180911_00062.jpg

LM Start	7.69	Rating **	U	Issue No.	75
LM End	7.72	Issue Type +	En	Location *	LS
Category	Earthen Levee			GPS Latitude/Longitude	
				Start	End
Item	Encroachments			38.559230 °	38.559261 °
				-121.402708 °	-121.402219 °
DWR ID	DWR_NA0001_04_s_2012_75				
Comment Code					
FE : Fence					
Inspector Comment					
Wooden privacy fence for seven apartment units is within 10-ft of levee toe and obstructs access and visibility.

03/16/2012 Wood privacy fence completely obstructs access and visibility.

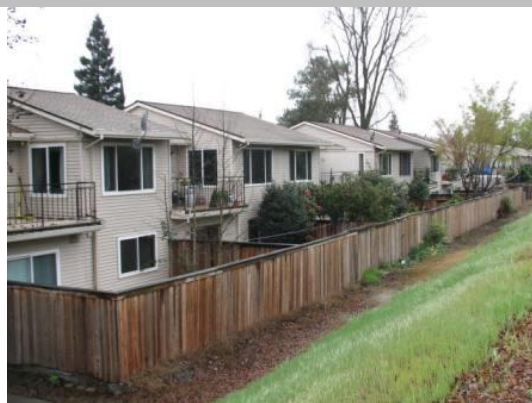
Photo 1 of 1 : FA_2018_NA0001_55_76_20180911_00063.jpg

LM Start	7.73	Rating **	U	Issue No.	76
LM End	7.76	Issue Type +	En	Location *	LS
Category	Earthen Levee			GPS Latitude/Longitude	
				Start	End
Item	Encroachments			38.559277 °	38.559309 °
				-121.401938 °	-121.401388 °
DWR ID	DWR_NA0001_04_s_2012_76				
Comment Code					
FE : Fence					
Inspector Comment					
Wooden privacy fence for seven apartment units is within 10-ft of levee toe and obstructs access and visibility.

03/16/2012 Wood privacy fence completely obstructs access and visibility.

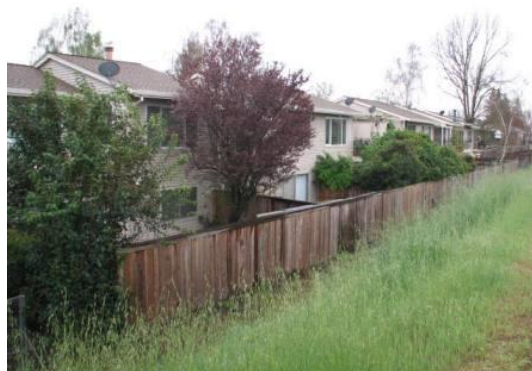
Photo 1 of 1 : FA_2018_NA0001_55_80_20180911_00067.jpg

LM Start	7.90	Rating **	U	Issue No.	80
LM End	7.93	Issue Type +	En	Location *	LS
Category	Earthen Levee			GPS Latitude/Longitude	
				Start	End
Item	Encroachments			38.559753 °	38.559911 °
				-121.398982 °	-121.398506 °
DWR ID	DWR_NA0001_04_s_2012_80				
Comment Code					
FE : Fence					
Inspector Comment					
Wooden privacy fence for seven apartment units is within 10-ft of levee toe and obstructs access and visibility. Concrete steps also placed on slope.

03/16/2012 Wood privacy fence completely obstructs access and visibility.

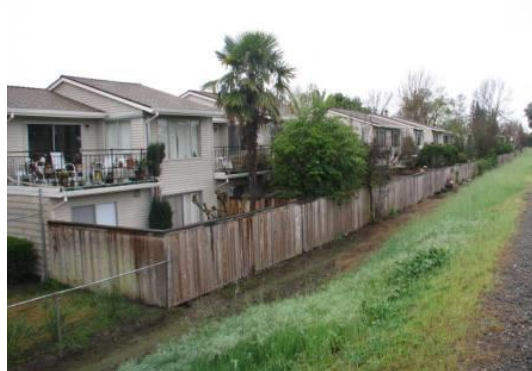
Photo 1 of 2 : FA_2018_NA0001_55_224_20180911_00184.jpg

LM Start	7.94	Rating **	U	Issue No.	224
LM End	8.02	Issue Type +	En	Location *	LS
Category	Earthen Levee			GPS Latitude/Longitude	
				Start	End
Item	Encroachments			38.559968 °	38.560505 °
				-121.398330 °	-121.396989 °
DWR ID	DWR_NA0001_04_s_2012_224				
Comment Code					
FE : Fence					
Inspector Comment					
Wooden privacy fence for seven apartment units is within 10-ft of levee toe and obstructs access and visibility.

03/16/2012 Wood privacy fence completely obstructs access and visibility.

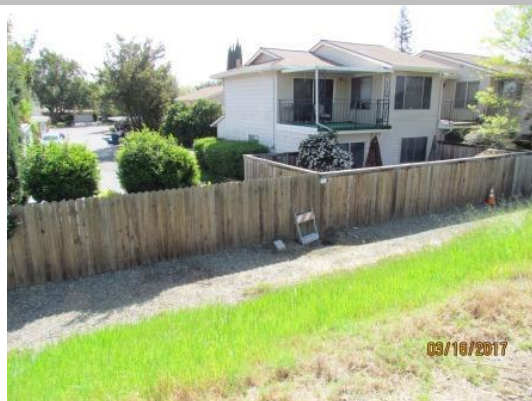
Photo 2 of 2 : FA_2018_NA0001_55_224_20180911_00185.jpg

Another view of the fence at the levee toe.

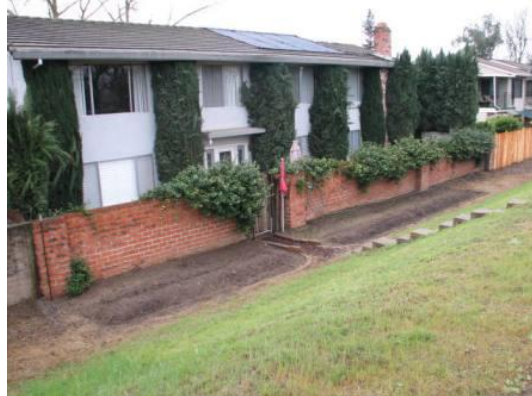
Photo 1 of 1 : FA_2018_NA0001_55_82_20180911_00068.jpg

LM Start	8.02	Rating **	U	Issue No.	82
LM End	8.02	Issue Type +	En	Location *	LS
Category	Earthen Levee			GPS Latitude/Longitude	
				Start	End
Item	Encroachments			38.560537 °	38.560537 °
				-121.396912 °	-121.396912 °
DWR ID	DWR_NA0001_04_s_2012_82				
Comment Code					
FE : Fence					
Inspector Comment					
Brick fence is within 10-ft of levee toe, obstructing access and visibility. Stairs also on slope.

03/16/2012 Brick wall completely obstructs access and visibility.

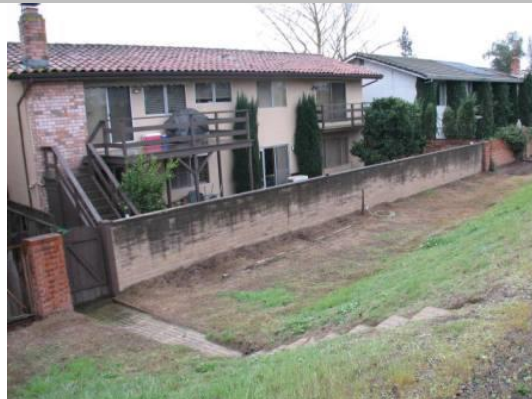
Photo 1 of 1 : FA_2018_NA0001_55_83_20180911_00069.jpg

LM Start	8.04	Rating **	U	Issue No.	83
LM End	8.04	Issue Type +	En	Location *	LS
Category	Earthen Levee			GPS Latitude/Longitude	
				Start	End
Item	Encroachments			38.560647 °	38.560647 °
				-121.396660 °	-121.396660 °
DWR ID	DWR_NA0001_04_s_2012_83				
Comment Code					
FE : Fence					
Inspector Comment					
Brick fence is within 10-ft of levee toe and obstructs access and visibility.

03/16/2012 Brick wall completely obstructs access and visibility.

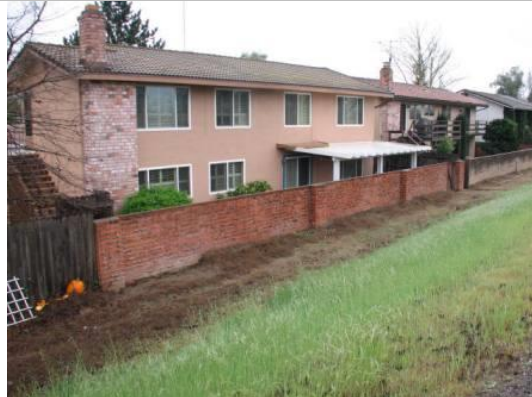
Photo 1 of 1 : FA_2018_NA0001_55_84_20180911_00070.jpg

LM Start	8.05	Rating **	U	Issue No.	84
LM End	8.05	Issue Type +	En	Location *	LS
Category	Earthen Levee			GPS Latitude/Longitude	
				Start	End
Item	Encroachments			38.560728 °	38.560728 °
				-121.396471 °	-121.396471 °
DWR ID	DWR_NA0001_04_s_2012_84				
Comment Code					
FE : Fence					
Inspector Comment					
Brick fence is within 10-ft of levee toe and obstructs access and visibility.

03/16/2012 Brick wall completely obstructs access and visibility.

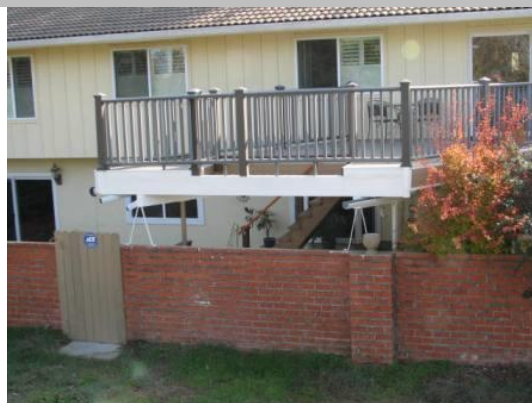
Photo 1 of 1 : FA_2018_NA0001_55_745_20180911_00211.jpg

LM Start	8.07	Rating **	A/W	Issue No.	745
LM End	8.07	Issue Type +	En	Location *	LS
Category	Earthen Levee			GPS Latitude/Longitude	
				Start	End
Item	Encroachments			38.560823 °	38.560823 °
				-121.396208 °	-121.396208 °
DWR ID	DWR_NA0001_04_s_2012_745				
Comment Code					
UR : Urban					
Inspector Comment					
Drains direct gutter flow onto levee toe.

11/15/2011 Gutter drains that are suspended from the balcony direct flow onto the levee toe.

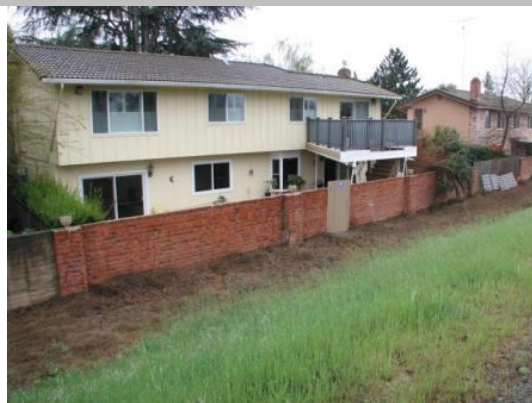
Photo 1 of 1 : FA_2018_NA0001_55_85_20180911_00071.jpg

LM Start	8.07	Rating **	U	Issue No.	85
LM End	8.07	Issue Type +	En	Location *	LS
Category	Earthen Levee			GPS Latitude/Longitude	
				Start	End
Item	Encroachments			38.560845 °	38.560845 °
				-121.396189 °	-121.396189 °
DWR ID	DWR_NA0001_04_s_2012_85				
Comment Code					
FE : Fence					
Inspector Comment					
Brick fence is within 10-ft of levee toe and obstructs access and visibility.

03/16/2012 Brick wall completely obstructs access and visibility.

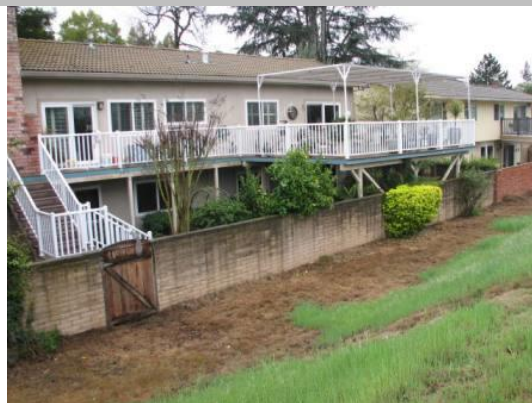
Photo 1 of 1 : FA_2018_NA0001_55_86_20180911_00072.jpg

LM Start	8.08	Rating **	U	Issue No.	86
LM End	8.08	Issue Type +	En	Location *	LS
Category	Earthen Levee			GPS Latitude/Longitude	
				Start	End
Item	Encroachments			38.560907 °	38.560907 °
				-121.396043 °	-121.396043 °
DWR ID	DWR_NA0001_04_s_2012_86				
Comment Code					
FE : Fence					
Inspector Comment					
Brick fence is within 10-ft of levee toe and obstructs access and visibility.

03/16/2012 Brick wall completely obstructs access and visibility.

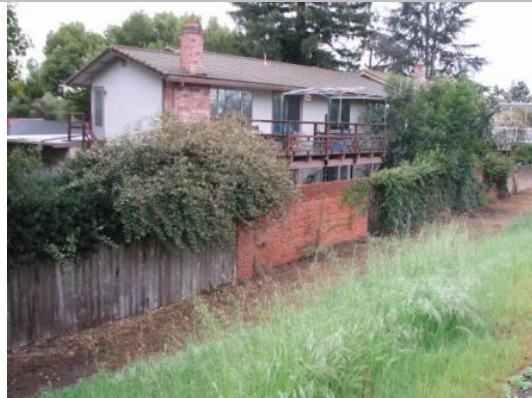
Photo 1 of 1 : FA_2018_NA0001_55_87_20180911_00073.jpg

LM Start	8.09	Rating **	U	Issue No.	87
LM End	8.09	Issue Type +	En	Location *	LS
Category	Earthen Levee			GPS Latitude/Longitude	
				Start	End
Item	Encroachments			38.561008 °	38.561008 °
				-121.395817 °	-121.395817 °
DWR ID	DWR_NA0001_04_s_2012_87				
Comment Code					
FE : Fence					
Inspector Comment					
Brick fence is within 10-ft of levee toe and obstructs access and visibility.

03/16/2012 Brick wall completely obstructs access and visibility.

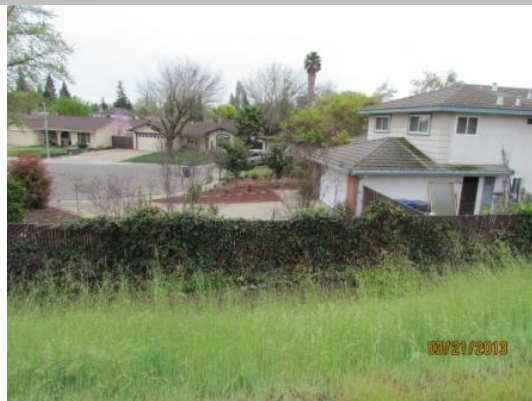
Photo 1 of 1 : FA_2018_NA0001_55_225_20180911_00186.jpg

LM Start	8.13	Rating **	M	Issue No.	225
LM End	8.13	Issue Type +	En	Location *	LS
Category	Earthen Levee			GPS Latitude/Longitude	
				Start	End
Item	Vegetation			38.561248 °	38.561248 °
				-121.395169 °	-121.395169 °
DWR ID	DWR_NA0001_04_s_2012_225				
Comment Code					
V6 : Landscaping					
Inspector Comment					
Landscaping along chain link fence within 10-ft of levee toe obstructs access and visibility.

View of the landscaping at the levee toe.

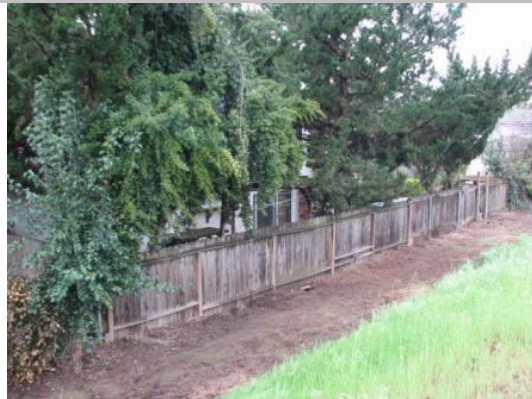
Photo 1 of 1 : FA_2018_NA0001_55_89_20180911_00075.jpg

LM Start	8.16	Rating **	U	Issue No.	89
LM End	8.16	Issue Type +	En	Location *	LS
Category	Earthen Levee			GPS Latitude/Longitude	
				Start	End
Item	Encroachments			38.561467 °	38.561467 °
				-121.394728 °	-121.394728 °
DWR ID	DWR_NA0001_04_s_2012_89				
Comment Code					
FE : Fence					
Inspector Comment					
Fence and landscaping arbor within 10-ft of levee toe obstructs access and visibility.

03/16/2012 Wood privacy fence completely obstructs access and visibility.

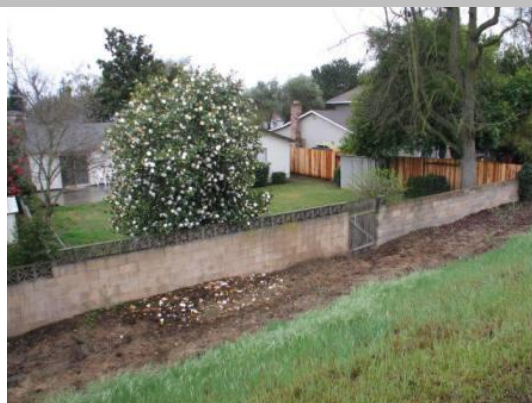
Photo 1 of 1 : FA_2018_NA0001_55_90_20180911_00076.jpg

LM Start	8.17	Rating **	U	Issue No.	90
LM End	8.17	Issue Type +	En	Location *	LS
Category	Earthen Levee			GPS Latitude/Longitude	
				Start	End
Item	Encroachments			38.561544 °	38.561544 °
				-121.394494 °	-121.394494 °
DWR ID	DWR_NA0001_04_s_2012_90				
Comment Code					
FE : Fence					
Inspector Comment					
Cement block fence within 10-ft of the levee toe.

03/16/2012 Cinder block wall completely obstructs access and visibility.

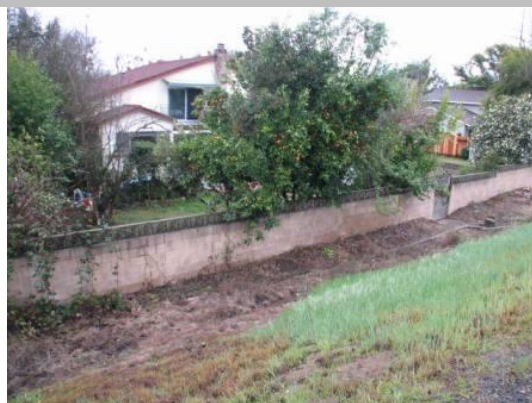
Photo 1 of 1 : FA_2018_NA0001_55_91_20180911_00077.jpg

LM Start	8.18	Rating **	U	Issue No.	91
LM End	8.18	Issue Type +	En	Location *	LS
Category	Earthen Levee			GPS Latitude/Longitude	
				Start	End
Item	Encroachments			38.561593 °	38.561593 °
				-121.394315 °	-121.394315 °
DWR ID	DWR_NA0001_04_s_2012_91				
Comment Code					
FE : Fence					
Inspector Comment					
Concrete block fence and landscaping within 10-ft of levee toe obstructs access and visibility.

03/16/2012 Cinder block wall completely obstructs access and visibility.

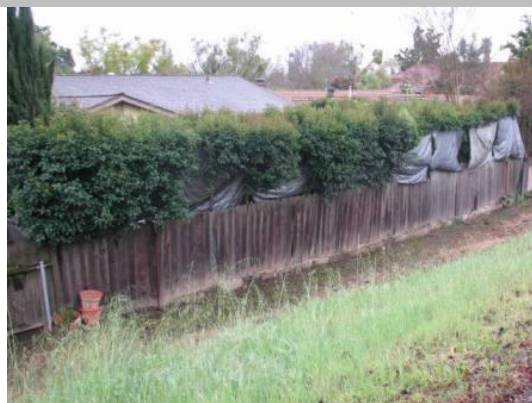
Photo 1 of 1 : FA_2018_NA0001_55_93_20180911_00079.jpg

LM Start	8.21	Rating **	U	Issue No.	93
LM End	8.21	Issue Type +	En	Location *	LS
Category	Earthen Levee			GPS Latitude/Longitude	
				Start	End
Item	Encroachments			38.561750 °	38.561750 °
				-121.393917 °	-121.393917 °
DWR ID	DWR_NA0001_04_s_2012_93				
Comment Code					
FE : Fence					
Inspector Comment					
Wooden fence and landscaping within 10-ft of levee toe obstructs access and visibility.

03/16/2012 Wood privacy fence completely obstructs access and visibility.

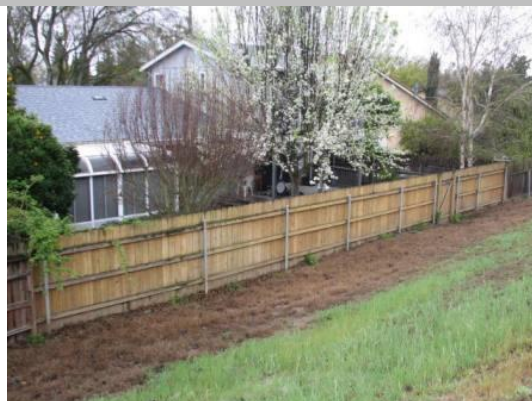
Photo 1 of 1 : FA_2018_NA0001_55_95_20180911_00081.jpg

LM Start	8.23	Rating **	U	Issue No.	95
LM End	8.23	Issue Type +	En	Location *	LS
Category	Earthen Levee			GPS Latitude/Longitude	
				Start	End
Item	Encroachments			38.561900 °	38.561900 °
				-121.393547 °	-121.393547 °
DWR ID	DWR_NA0001_04_s_2012_95				
Comment Code					
FE : Fence					
Inspector Comment					
Wood privacy fence within 10-ft of levee toe obstructs access and visibility.

03/16/2012 Wood privacy fence completely obstructs access and visibility.

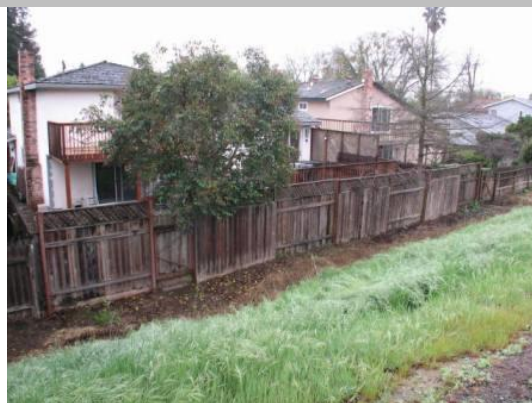
Photo 1 of 1 : FA_2018_NA0001_55_98_20180911_00084.jpg

LM Start	8.25	Rating **	U	Issue No.	98
LM End	8.25	Issue Type +	En	Location *	LS
Category	Earthen Levee			GPS Latitude/Longitude	
				Start	End
Item	Encroachments			38.562054 °	38.562054 °
				-121.393190 °	-121.393190 °
DWR ID	DWR_NA0001_04_s_2012_98				
Comment Code					
FE : Fence					
Inspector Comment					
Wood privacy fence within 10-ft of levee toe obstructs access and visibility.

03/16/2012 Wood privacy fence completely obstructs access and visibility.

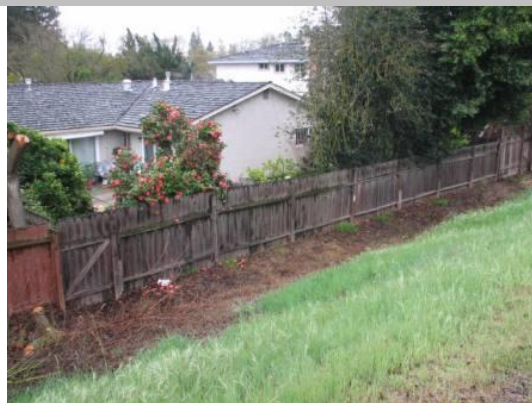
Photo 1 of 1 : FA_2018_NA0001_55_99_20180911_00085.jpg

LM Start	8.26	Rating **	U	Issue No.	99
LM End	8.26	Issue Type +	En	Location *	LS
Category	Earthen Levee			GPS Latitude/Longitude	
				Start	End
Item	Encroachments			38.562120 °	38.562120 °
				-121.392983 °	-121.392983 °
DWR ID	DWR_NA0001_04_s_2012_99				
Comment Code					
FE : Fence					
Inspector Comment					
Wood privacy fence within 10-ft of levee toe obstructs access and visibility.

03/16/2012 Wood privacy fence completely obstructs access and visibility.

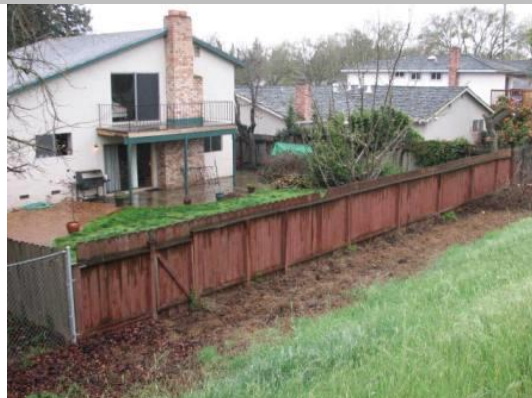
Photo 1 of 1 : FA_2018_NA0001_55_100_20180911_00086.jpg

LM Start	8.27	Rating **	U	Issue No.	100
LM End	8.27	Issue Type +	En	Location *	LS
Category	Earthen Levee			GPS Latitude/Longitude	
				Start	End
Item	Encroachments			38.562182°	38.562182°
				-121.392778°	-121.392778°
DWR ID	DWR_NA0001_04_s_2012_100				
Comment Code					
FE : Fence					
Inspector Comment					
Wood privacy fence within 10-ft of levee toe obstructs access and visibility.

03/16/2012 Wood privacy fence completely obstructs access and visibility.

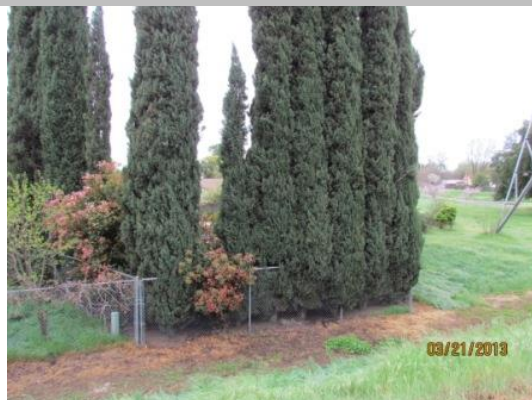
Photo 1 of 1 : FA_2018_NA0001_55_102_20180911_00088.jpg

LM Start	8.38	Rating **	M	Issue No.	102
LM End	8.38	Issue Type +	En	Location *	LS
Category	Earthen Levee			GPS Latitude/Longitude	
				Start	End
Item	Vegetation			38.562889 °	38.562889 °
				-121.391042 °	-121.391042 °
DWR ID	DWR_NA0001_04_s_2012_102				
Comment Code					
V6 : Landscaping					
Inspector Comment					
Helix sky pencil along chain link fence is within 10-ft of the levee toe.

View of the landscaping at the levee toe.

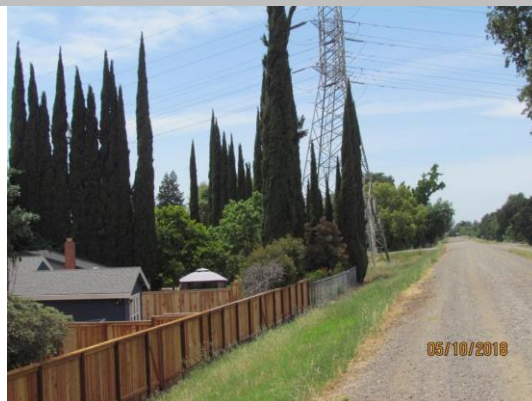
Photo 1 of 2 : FA_2018_NA0001_55_103_20180911_00089.jpg

LM Start	8.40	Rating **	U	Issue No.	103
LM End	8.40	Issue Type +	En	Location *	LS
Category	Earthen Levee			GPS Latitude/Longitude	
				Start	End
Item	Encroachments			38.563042 °	38.563042 °
				-121.390692 °	-121.390692 °
DWR ID	DWR_NA0001_04_s_2012_103				
Comment Code					
FE : Fence					
Inspector Comment					
Wood privacy fence within 10-ft of levee toe obstructs access and visibility.

View looking downstream landside of the new wood privacy fence that completely obstructs access and visibility, Spring 2018.

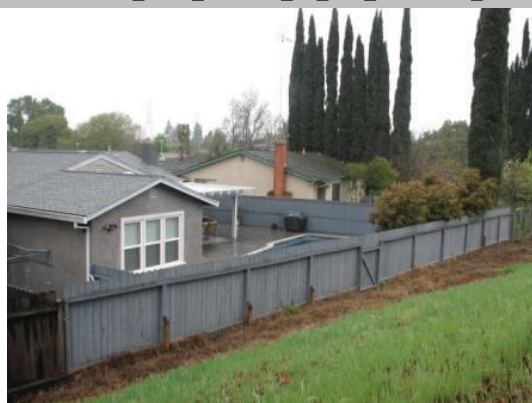
Photo 2 of 2 : FA_2018_NA0001_55_103_20180911_00090.jpg

03/16/2012 Wood privacy fence completely obstructs access and visibility.

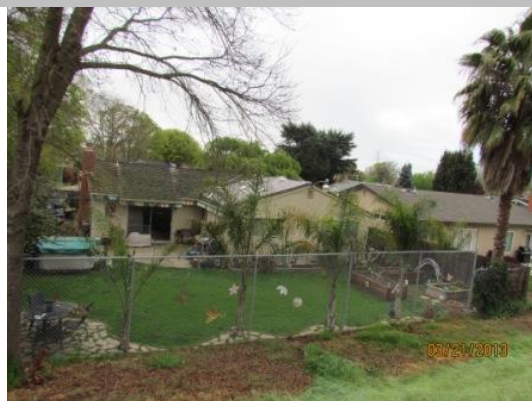
Photo 1 of 1 : FA_2018_NA0001_55_105_20180911_00093.jpg

LM Start	8.44	Rating **	M	Issue No.	105
LM End	8.44	Issue Type +	En	Location *	LS
Category	Earthen Levee			GPS Latitude/Longitude	
				Start	End
Item	Vegetation			38.563238 °	38.563238 °
				-121.390073 °	-121.390073 °
DWR ID	DWR_NA0001_04_s_2012_105				
Comment Code					
V6 : Landscaping					
Inspector Comment					
Palms planted within 10-ft of the levee toe.

View of the palm trees at the levee toe.

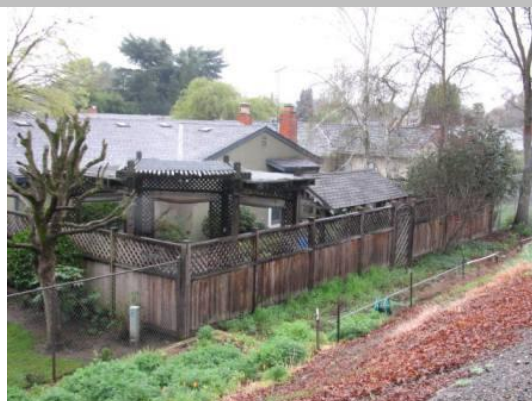
Photo 1 of 1 : FA_2018_NA0001_55_106_20180911_00094.jpg

LM Start	8.45	Rating **	U	Issue No.	106
LM End	8.45	Issue Type +	En	Location *	LS
Category	Earthen Levee			GPS Latitude/Longitude	
				Start	End
Item	Encroachments			38.563308 °	38.563308 °
				-121.389885 °	-121.389885 °
DWR ID	DWR_NA0001_04_s_2012_106				
Comment Code					
FE : Fence					
Inspector Comment					
Wood privacy fence within 10-ft of levee toe obstructs access and visibility. Block wall built into the levee.

03/16/2012 Wood privacy fence completely obstructs access and visibility.

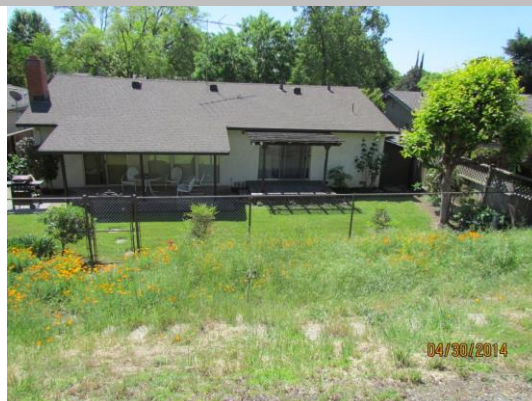
Photo 1 of 1 : FA_2018_NA0001_55_246_20180911_00198.jpg

LM Start	8.46	Rating **	M	Issue No.	246
LM End	8.46	Issue Type +	En	Location *	LS
Category	Earthen Levee			GPS Latitude/Longitude	
				Start	End
Item	Encroachments			38.563434 °	38.563434 °
				-121.389675 °	-121.389675 °
DWR ID	DWR_NA0001_04_s_2014_246				
Comment Code					
RW : Retaining Wall					
Inspector Comment					
Retaining wall, concrete steps, and irrigation at landside levee toe.

View of the irrigation and retaining wall at the landside levee toe.

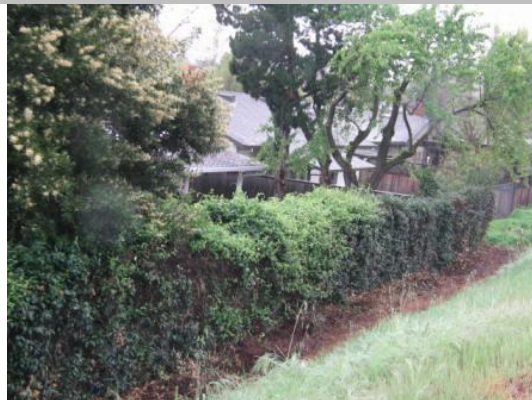
Photo 1 of 1 : FA_2018_NA0001_55_107_20180911_00095.jpg

LM Start	8.47	Rating **	U	Issue No.	107
LM End	8.47	Issue Type +	En	Location *	LS
Category	Earthen Levee			GPS Latitude/Longitude	
				Start	End
Item	Vegetation			38.563511 °	38.563511 °
				-121.389509 °	-121.389509 °
DWR ID	DWR_NA0001_04_s_2012_107				
Comment Code					
V6 : Landscaping					
Inspector Comment

03/16/2012 Landscaping obstructs visibility and access.

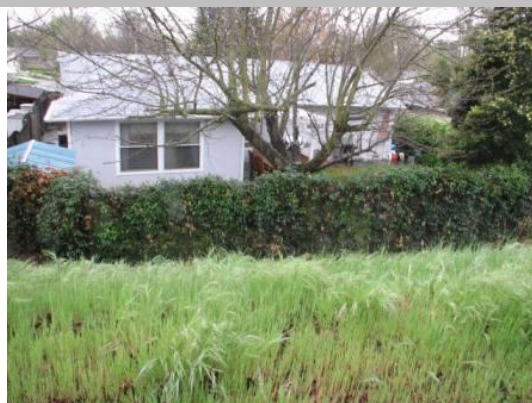
Photo 1 of 1 : FA_2018_NA0001_55_108_20180911_00096.jpg

LM Start	8.48	Rating **	U	Issue No.	108
LM End	8.48	Issue Type +	En	Location *	LS
Category	Earthen Levee			GPS Latitude/Longitude	
				Start	End
Item	Vegetation			38.563587 °	38.563587 °
				-121.389313 °	-121.389313 °
DWR ID	DWR_NA0001_04_s_2012_108				
Comment Code					
V6 : Landscaping					
Inspector Comment

03/16/2012 Landscaping obstructs visibility and access.

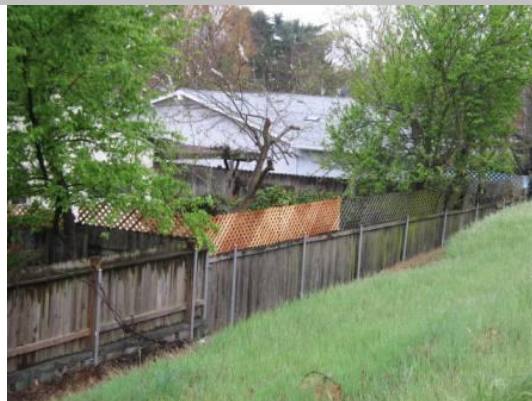
Photo 1 of 1 : FA_2018_NA0001_55_109_20180911_00097.jpg

LM Start	8.49	Rating **	U	Issue No.	109
LM End	8.49	Issue Type +	En	Location *	LS
Category	Earthen Levee			GPS Latitude/Longitude	
				Start	End
Item	Encroachments			38.563580 °	38.563580 °
				-121.389140 °	-121.389140 °
DWR ID	DWR_NA0001_04_s_2012_109				
Comment Code					
FE : Fence					
Inspector Comment					
Wood privacy fence within 10-ft of levee toe obstructs access and visibility.

03/16/2012 Wood privacy fence completely obstructs access and visibility.

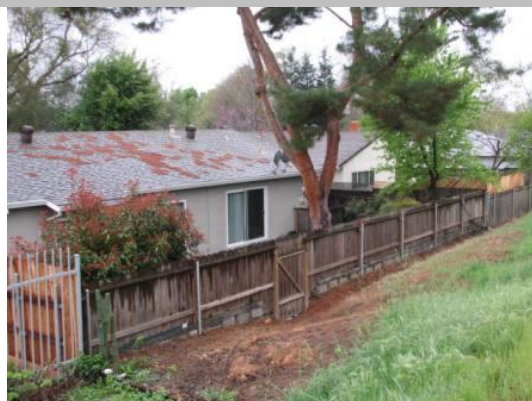
Photo 1 of 1 : FA_2018_NA0001_55_110_20180911_00098.jpg

LM Start	8.51	Rating **	U	Issue No.	110
LM End	8.51	Issue Type +	En	Location *	LS
Category	Earthen Levee			GPS Latitude/Longitude	
				Start	End
Item	Encroachments			38.563732 °	38.563732 °
				-121.388930 °	-121.388930 °
DWR ID	DWR_NA0001_04_s_2012_110				
Comment Code					
FE : Fence					
Inspector Comment					
Wood privacy fence within 10-ft of levee toe obstructs access and visibility.

03/16/2012 Wood privacy fence completely obstructs access and visibility.

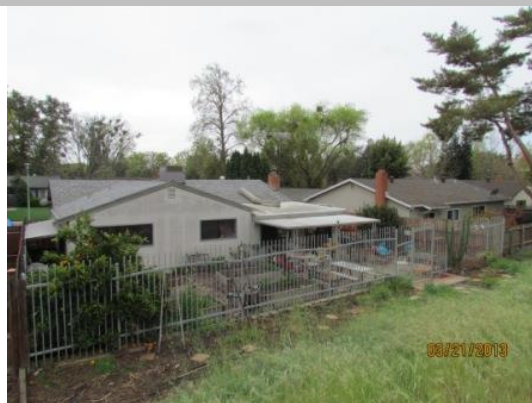
Photo 1 of 1 : FA_2018_NA0001_55_226_20180911_00187.jpg

LM Start	8.52	Rating **	M	Issue No.	226
LM End	8.52	Issue Type +	En	Location *	LS
Category	Earthen Levee			GPS Latitude/Longitude	
				Start	End
Item	Vegetation			38.563793 °	38.563793 °
				-121.388758 °	-121.388758 °
DWR ID	DWR_NA0001_04_s_2012_226				
Comment Code					
V6 : Landscaping					
Inspector Comment					
Garden, trees, and cactus planted against the levee toe.

View of landscaping at the levee toe.

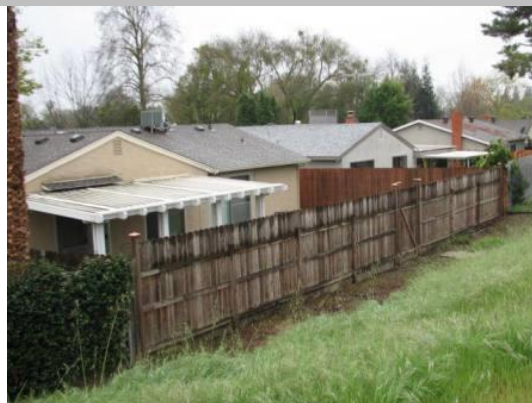
Photo 1 of 1 : FA_2018_NA0001_55_111_20180911_00099.jpg

LM Start	8.53	Rating **	U	Issue No.	111
LM End	8.53	Issue Type +	En	Location *	LS
Category	Earthen Levee			GPS Latitude/Longitude	
				Start	End
Item	Encroachments			38.563820°	38.563820°
				-121.388518°	-121.388518°
DWR ID	DWR_NA0001_04_s_2012_111				
Comment Code					
FE : Fence					
Inspector Comment					
Wood privacy fence within 10-ft of levee toe obstructs access and visibility.

03/16/2012 Wood privacy fence completely obstructs access and visibility.

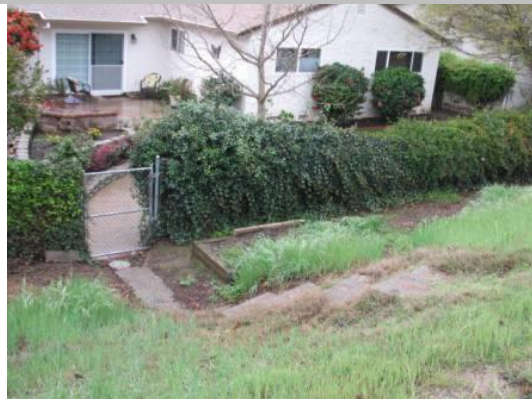
Photo 1 of 1 : FA_2018_NA0001_55_113_20180911_00101.jpg

LM Start	8.55	Rating **	U	Issue No.	113
LM End	8.55	Issue Type +	En	Location *	LS
Category	Earthen Levee			GPS Latitude/Longitude	
				Start	End
Item	Vegetation			38.563963 °	38.563963 °
				-121.388135 °	-121.388135 °
DWR ID	DWR_NA0001_04_s_2012_113				
Comment Code					
V6 : Landscaping					
Inspector Comment

03/16/2012 Landscaping on chainlink fence blocks visibility and access.

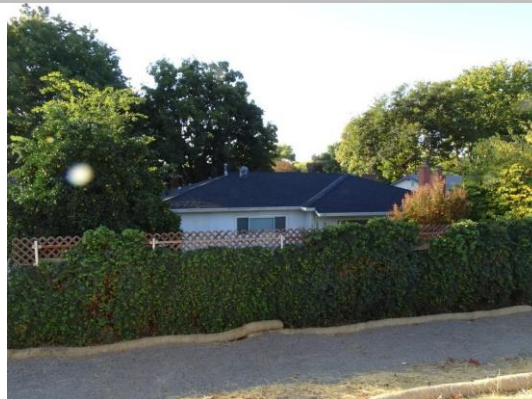
Photo 1 of 2 : FA_2018_NA0001_55_114_20181024_00274.jpg

LM Start	8.57	Rating **	U	Issue No.	114
LM End	8.57	Issue Type +	En	Location *	LS
Category	Earthen Levee			GPS Latitude/Longitude	
				Start	End
Item	Vegetation			38.564020 °	38.564020 °
				-121.387887 °	-121.387887 °
DWR ID	DWR_NA0001_04_s_2012_114				
Comment Code					
V6 : Landscaping					
Inspector Comment					
Ivy and orange tree obstruct visibility.

View of fence with added lattice that obstructs visibility and access. Fall 2018

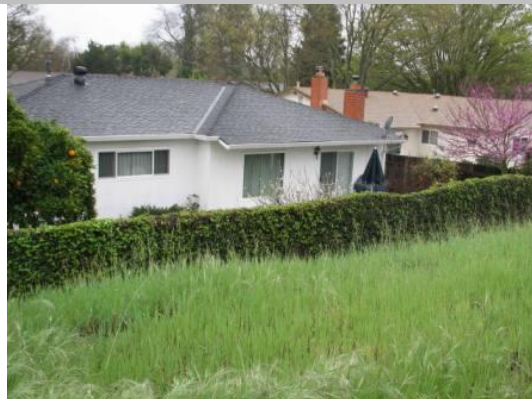
Photo 2 of 2 : FA_2018_NA0001_55_114_20180911_00102.jpg

03/16/2012 Ivy on chainlink fence completely obstructs visibility and access.

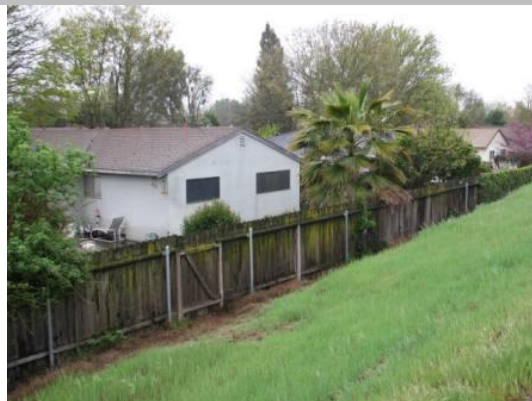
Photo 1 of 1 : FA_2018_NA0001_55_115_20180911_00103.jpg

LM Start	8.58	Rating **	U	Issue No.	115
LM End	8.58	Issue Type +	En	Location *	LS
Category	Earthen Levee			GPS Latitude/Longitude	
				Start	End
Item	Encroachments			38.564047°	38.564047°
				-121.387743°	-121.387743°
DWR ID	DWR_NA0001_04_s_2012_115				
Comment Code					
FE : Fence					
Inspector Comment					
Wood privacy fence within 10-ft of levee toe obstructs access and visibility.

03/16/2012 Wood privacy fence completely obstructs access and visibility.

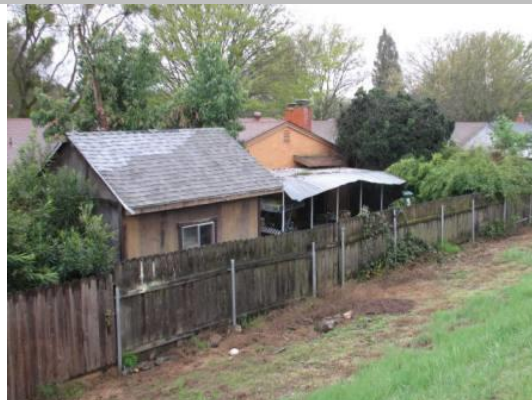
Photo 1 of 1 : FA_2018_NA0001_55_117_20180911_00105.jpg

LM Start	8.59	Rating **	U	Issue No.	117
LM End	8.59	Issue Type +	En	Location *	LS
Category	Earthen Levee			GPS Latitude/Longitude	
				Start	End
Item	Encroachments			38.564094°	38.564094°
				-121.387498°	-121.387498°
DWR ID	DWR_NA0001_04_s_2012_117				
Comment Code					
FE : Fence					
Inspector Comment					
Wood privacy fence within 10-ft of levee toe obstructs access and visibility.

03/16/2012 Wood privacy fence completely obstructs access and visibility.

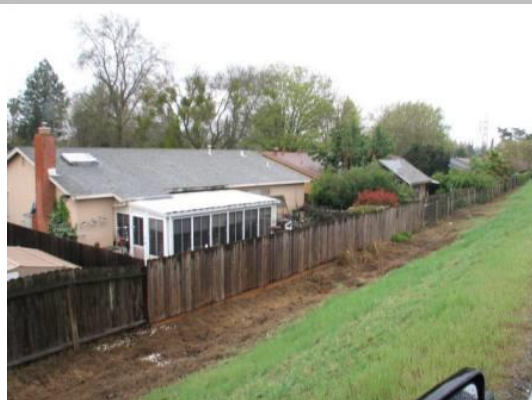
Photo 1 of 1 : FA_2018_NA0001_55_116_20180911_00104.jpg

LM Start	8.60	Rating **	U	Issue No.	116
LM End	8.60	Issue Type +	En	Location *	LS
Category	Earthen Levee			GPS Latitude/Longitude	
				Start	End
Item	Encroachments			38.564133°	38.564133°
				-121.387318°	-121.387318°
DWR ID	DWR_NA0001_04_s_2012_116				
Comment Code					
FE : Fence					
Inspector Comment					
Wood privacy fence within 10-ft of levee toe obstructs access and visibility.

03/16/2012 Wood privacy fence completely obstructs access and visibility.

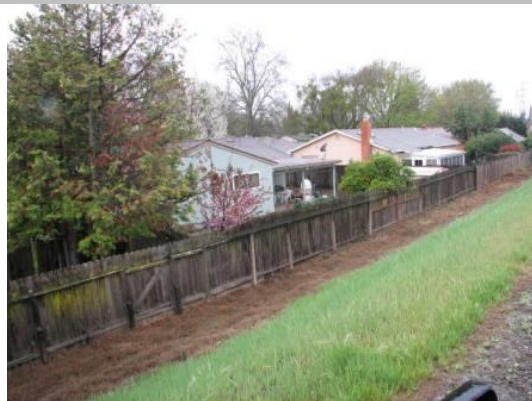
Photo 1 of 1 : FA_2018_NA0001_55_118_20180911_00106.jpg

LM Start	8.61	Rating **	U	Issue No.	118
LM End	8.61	Issue Type +	En	Location *	LS
Category	Earthen Levee			GPS Latitude/Longitude	
				Start	End
Item	Encroachments			38.564133 °	38.564133 °
				-121.387092 °	-121.387092 °
DWR ID	DWR_NA0001_04_s_2018_118				
Comment Code					
FE : Fence					
Inspector Comment					
Wood privacy fence within 10-ft of levee toe obstructs access and visibility.

03/16/2012 Wood privacy fence completely obstructs access and visibility.

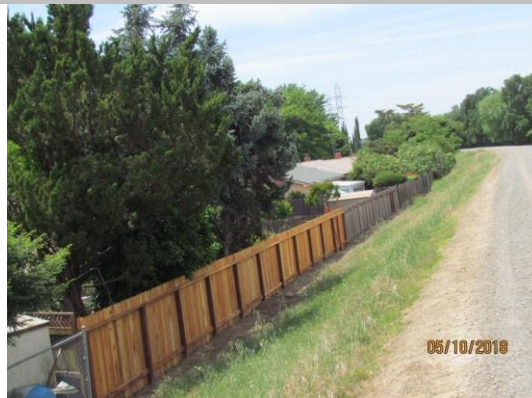
Photo 1 of 1 : FA_2018_NA0001_55_119_20180911_00107.jpg

LM Start	8.63	Rating **	U	Issue No.	119
LM End	8.63	Issue Type +	En	Location *	LS
Category	Earthen Levee			GPS Latitude/Longitude	
				Start	End
Item	Encroachments			38.564217 °	38.564217 °
				-121.386846 °	-121.386846 °
DWR ID	DWR_NA0001_04_s_2012_119				
Comment Code					
FE : Fence					
Inspector Comment					
Wood privacy fence still completely obstructs access and visibility.

New wood privacy fence still completely obstructs access and visibility, Spring 2018.

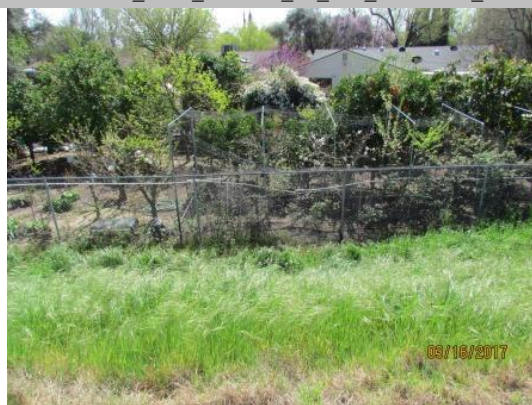
Photo 1 of 1 : FA_2018_NA0001_55_254_20180911_00204.jpg

LM Start	8.64	Rating **	M	Issue No.	254
LM End	8.64	Issue Type +	En	Location *	LS
Category	Earthen Levee			GPS Latitude/Longitude	
				Start	End
Item	Encroachments			38.564257 °	38.564257 °
				-121.386543 °	-121.386543 °
DWR ID	DWR_NA0001_04_s_2017_254				
Comment Code					
FE : Fence					
Inspector Comment					
Chain link fence blocks access.

View of the fence at the levee toe.

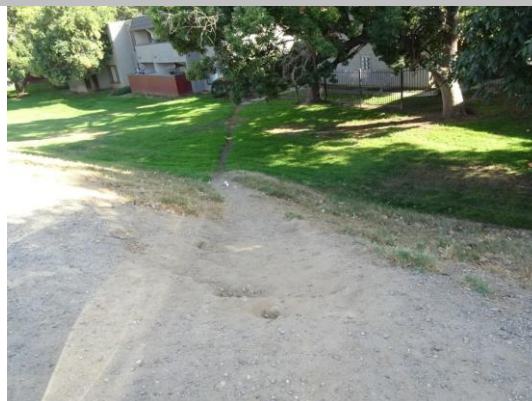
Photo 1 of 1 : FA_2018_NA0001_55_252_20181024_00272.jpg

LM Start	8.95	Rating **	A/W	Issue No.	252
LM End	8.95	Issue Type +	Ma	Location *	LS
Category	Earthen Levee			GPS Latitude/Longitude	
				Start	End
Item	Slope Stability			38.565696 °	38.565696 °
				-121.381141 °	-121.381141 °
DWR ID	DWR_NA0001_04_f_2018_252				
Comment Code					
S2 : Repair the levee slope damaged by foot traffic and prevent access where possible.					
Inspector Comment					
Monitor slope damage from foot traffic.

View of footpath on levee toe. Fall 2018

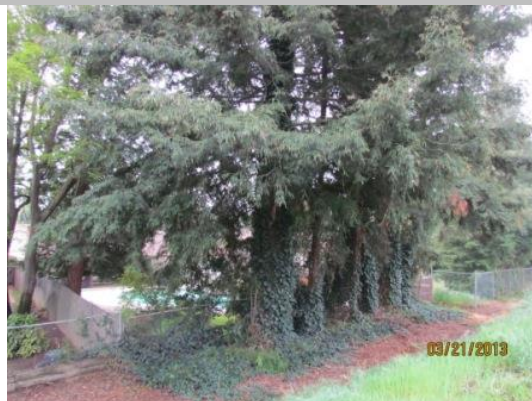
Photo 1 of 1 : FA_2018_NA0001_55_237_20180911_00192.jpg

LM Start	9.48	Rating **	M	Issue No.	237
LM End	9.48	Issue Type +	En	Location *	LS
Category	Earthen Levee			GPS Latitude/Longitude	
				Start	End
Item	Vegetation			38.566961°	38.566961°
				-121.371544°	-121.371544°
DWR ID	DWR_NA0001_04_s_2012_237				
Comment Code					
V6 : Landscaping					
Inspector Comment					
Redwoods and ivy along fence within 10-ft of levee toe.

View of landscaping at levee toe.

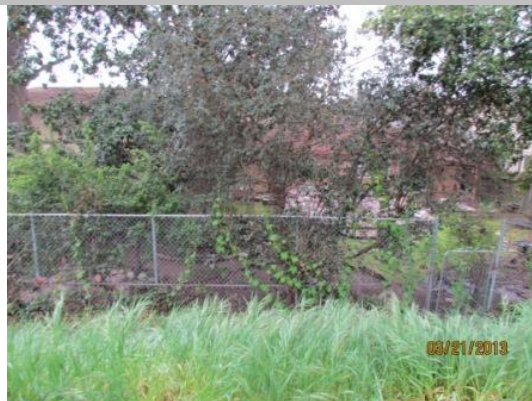
Photo 1 of 1 : FA_2018_NA0001_55_122_20180911_00108.jpg

LM Start	9.55	Rating **	M	Issue No.	122
LM End	9.55	Issue Type +	En	Location *	LS
Category	Earthen Levee		GPS Latitude/Longitude		
			Start	End	
Item	Vegetation		38.567181°	38.567181°	
			-121.370366°	-121.370366°	
DWR ID	DWR_NA0001_04_s_2012_122				
Comment Code					
V6 : Landscaping					
Inspector Comment					
Trees and ground cover within 10-ft of levee toe.

View of landscaping at levee toe.

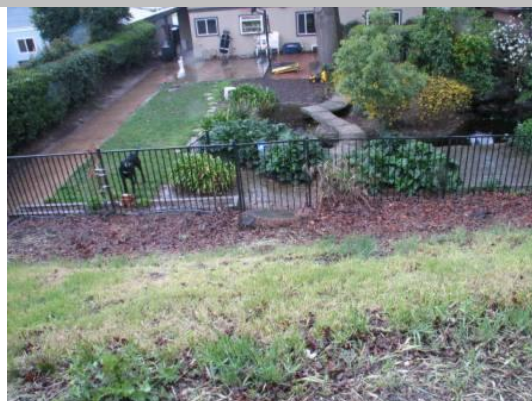
Photo 1 of 1 : FA_2018_NA0001_55_123_20180911_00109.jpg

LM Start	9.56	Rating **	N	Issue No.	123
LM End	9.56	Issue Type +	Ma	Location *	LS
Category	Earthen Levee			GPS Latitude/Longitude	
				Start	End
Item	Trim / Thin Trees			38.567246°	38.567246°
				-121.370146°	-121.370146°
DWR ID	DWR_NA0001_04_s_2012_123				
Comment Code					
T5 : Tree stumps.					
Inspector Comment					
Trees, bushes, and ground cover within 10-ft of levee toe.

03/16/2012 Large tree stump at levee toe.

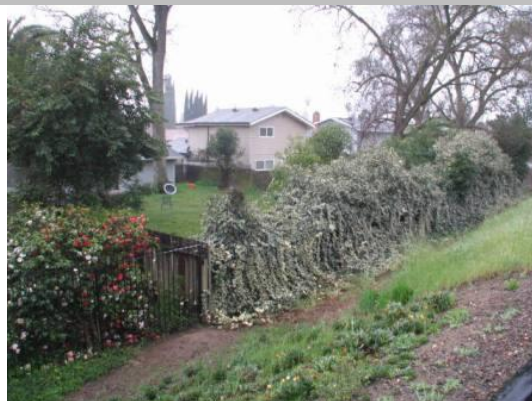
Photo 1 of 1 : FA_2018_NA0001_55_125_20180911_00111.jpg

LM Start	9.60	Rating **	U	Issue No.	125
LM End	9.60	Issue Type +	En	Location *	LS
Category	Earthen Levee			GPS Latitude/Longitude	
				Start	End
Item	Vegetation			38.567360 °	38.567360 °
				-121.369555 °	-121.369555 °
DWR ID	DWR_NA0001_04_s_2012_125				
Comment Code					
V6 : Landscaping					
Inspector Comment					
Dense golden ivy on C/L fence obstructs access and visibility.

03/16/2012 Landscaping obstructs visibility and access.

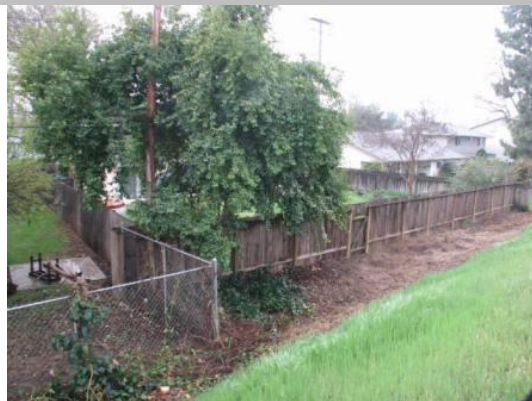
Photo 1 of 1 : FA_2018_NA0001_55_128_20180911_00112.jpg

LM Start	9.65	Rating **	U	Issue No.	128
LM End	9.65	Issue Type +	En	Location *	LS
Category	Earthen Levee			GPS Latitude/Longitude	
				Start	End
Item	Encroachments			38.567493 °	38.567493 °
				-121.368633 °	-121.368633 °
DWR ID	DWR_NA0001_04_s_2012_128				
Comment Code					
FE : Fence					
Inspector Comment					
Wooden privacy fence within 10-ft of levee toe.

03/16/2012 Wood privacy fence completely obstructs access and visibility.

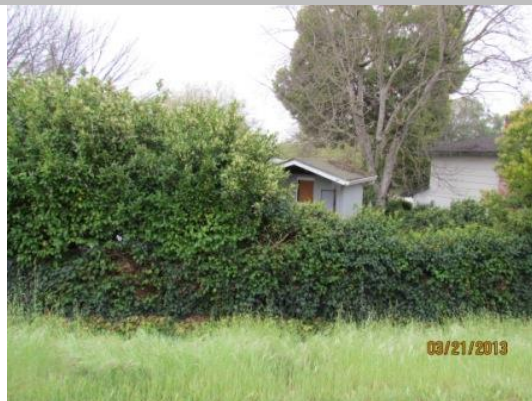
Photo 1 of 1 : FA_2018_NA0001_55_134_20180911_00117.jpg

LM Start	9.77	Rating **	U	Issue No.	134
LM End	9.77	Issue Type +	En	Location *	LS
Category	Earthen Levee			GPS Latitude/Longitude	
				Start	End
Item	Vegetation			38.567873 °	38.567873 °
				-121.366410 °	-121.366410 °
DWR ID	DWR_NA0001_04_s _ 2012_134				
Comment Code					
V6 : Landscaping					
Inspector Comment					
Ivy, hedge, and play house are within 10-ft of levee toe.

View of landscaping and playhouse that are within 10 ft. of levee toe.

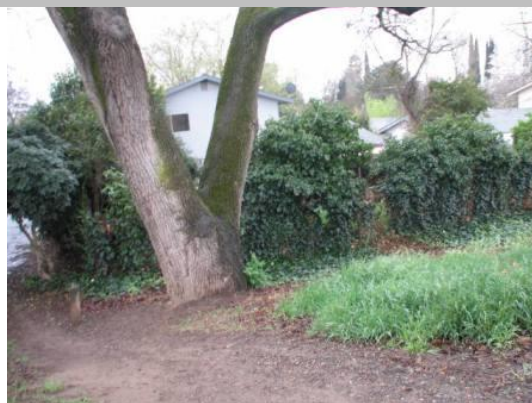
Photo 1 of 1 : FA_2018_NA0001_55_135_20180911_00118.jpg

LM Start	9.88	Rating **	U	Issue No.	135
LM End	9.88	Issue Type +	En	Location *	LS
Category	Earthen Levee			GPS Latitude/Longitude	
				Start	End
Item	Vegetation			38.568411 °	38.568411 °
				-121.364489 °	-121.364489 °
DWR ID	DWR_NA0001_04_s_2012_135				
Comment Code					
V6 : Landscaping					
Inspector Comment					
Tall hedge and ivy within 10-ft of landside levee toe.

03/16/2012 Landscaping is obstructing visibility.

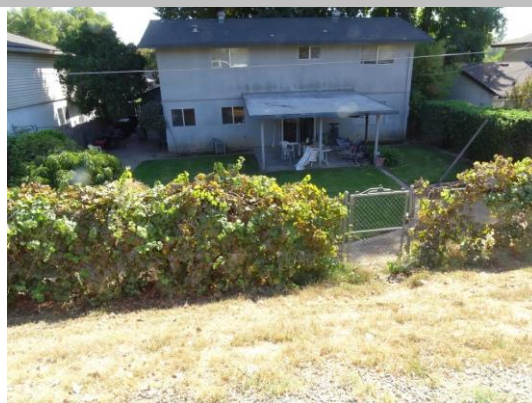
Photo 1 of 1 : FA_2018_NA0001_55_229_20181024_00270.jpg

LM Start	9.93	Rating **	M	Issue No.	229
LM End	9.93	Issue Type +	En	Location *	LS
Category	Earthen Levee			GPS Latitude/Longitude	
				Start	End
Item	Encroachments			38.568647 °	38.568647 °
				-121.363585 °	-121.363585 °
DWR ID	DWR_NA0001_04_s_2017_229				
Comment Code					
FE : Fence					
Inspector Comment					
Fence with grapevine blocking access.

View of landowner vegetation blocking visibility and access. Fall 2018

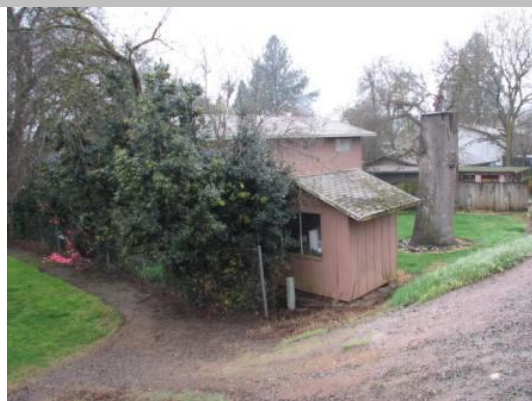
Photo 1 of 1 : FA_2018_NA0001_55_176_20180911_00153.jpg

LM Start	10.08	Rating **	U	Issue No.	176
LM End	10.08	Issue Type +	En	Location *	LS
Category	Earthen Levee			GPS Latitude/Longitude	
				Start	End
Item	Encroachments			38.569293°	38.569293°
				-121.361002°	-121.361002°
DWR ID	DWR_NA0001_04_s_2012_176				
Comment Code					
BU : Building					
Inspector Comment

03/16/2012 Wood structure within 15' of levee toe.

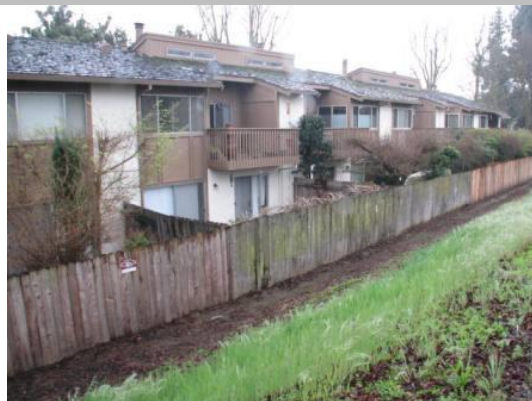
Photo 1 of 1 : FA_2018_NA0001_55_141_20180911_00122.jpg

LM Start	10.24	Rating **	U	Issue No.	141
LM End	10.27	Issue Type +	En	Location *	LS
Category	Earthen Levee			GPS Latitude/Longitude	
				Start	End
Item	Encroachments			38.569982 °	38.570118 °
				-121.358134 °	-121.357604 °
DWR ID	DWR_NA0001_04_s_2012_141				
Comment Code					
FE : Fence					
Inspector Comment					
Wooden fence behind six apartment units is within 10-ft of levee slope.

03/16/2012 Wood privacy fence completely obstructs access and visibility.

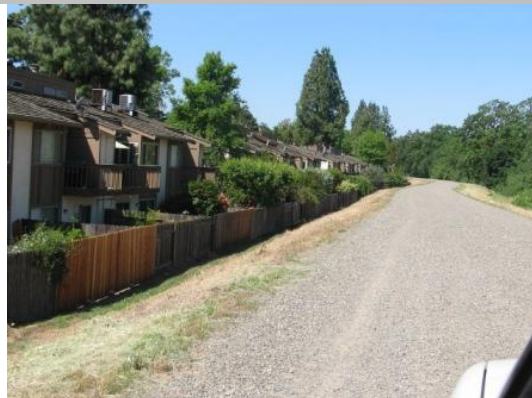
Photo 1 of 1 : FA_2018_NA0001_55_142_20180911_00123.jpg

LM Start	10.28	Rating **	U	Issue No.	142
LM End	10.30	Issue Type +	En	Location *	LS
Category	Earthen Levee			GPS Latitude/Longitude	
				Start	End
Item	Encroachments			38.570175 °	38.570229 °
				-121.357390 °	-121.357041 °
DWR ID	DWR_NA0001_04_s_2017_142				
Comment Code					
FE : Fence					
Inspector Comment					
Wooden fence behind six apartment units is within 10-ft of levee slope.

Wooden fence behind apartments is within 10' of levee toe.

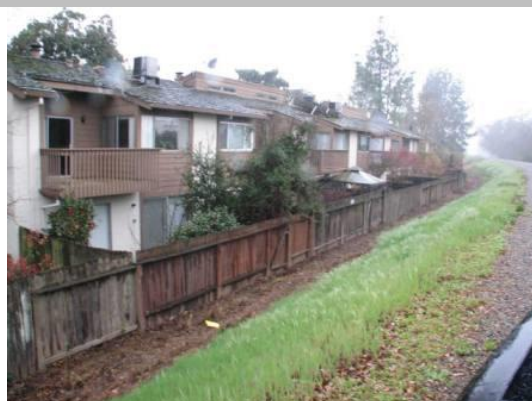
Photo 1 of 1 : FA_2018_NA0001_55_146_20180911_00127.jpg

LM Start	10.30	Rating **	U	Issue No.	146
LM End	10.32	Issue Type +	En	Location *	LS
Category	Earthen Levee			GPS Latitude/Longitude	
				Start	End
Item	Encroachments			38.570225 °	38.570245 °
				-121.357014 °	-121.356791 °
DWR ID	DWR_NA0001_04_s_2012_146				
Comment Code					
FE : Fence					
Inspector Comment					
Wooden fence behind 6 apartments.

03/16/2012 Wood privacy fence completely obstructs access and visibility.

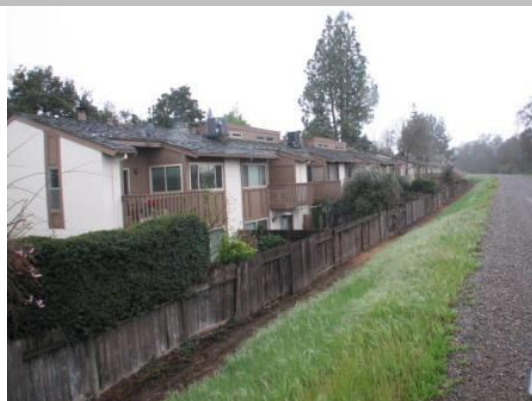
Photo 1 of 1 : FA_2018_NA0001_55_143_20180911_00124.jpg

LM Start	10.32	Rating **	U	Issue No.	143
LM End	10.34	Issue Type +	En	Location *	LS
Category	Earthen Levee			GPS Latitude/Longitude	
				Start	End
Item	Encroachments			38.570257 °	38.570297 °
				-121.356783 °	-121.356403 °
DWR ID	DWR_NA0001_04_f_2018_143				
Comment Code					
FE : Fence					
Inspector Comment					
Wooden fence behind six apartment units is within 10-ft of levee slope.

03/16/2012 Wood privacy fence completely obstructs access and visibility.

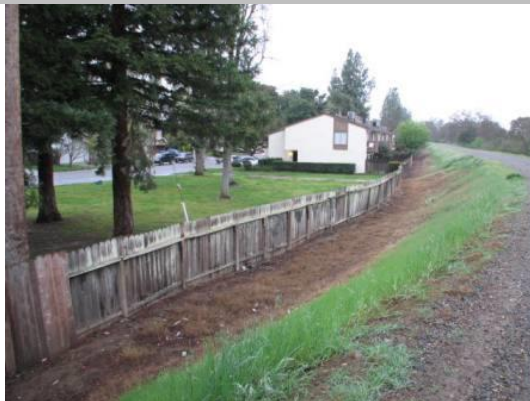
Photo 1 of 1 : FA_2018_NA0001_55_147_20180911_00128.jpg

LM Start	10.43	Rating **	U	Issue No.	147
LM End	10.43	Issue Type +	En	Location *	LS
Category	Earthen Levee			GPS Latitude/Longitude	
				Start	End
Item	Encroachments			38.570542 °	38.570542 °
				-121.354772 °	-121.354772 °
DWR ID	DWR_NA0001_04_s_2012_147				
Comment Code					
FE : Fence					
Inspector Comment					
Wooden privacy fence obstructs access and visibility.

03/16/2012 Wood privacy fence completely obstructs access and visibility.

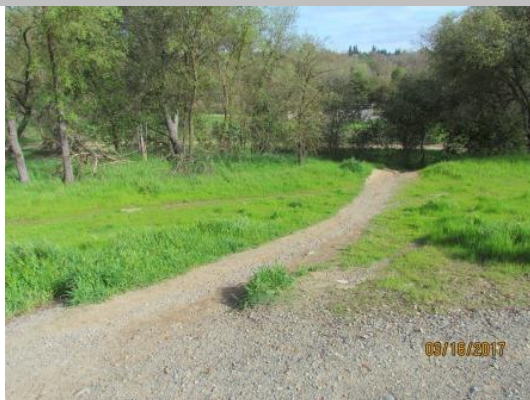
Photo 1 of 1 : FA_2018_NA0001_55_219_20180911_00181.jpg

LM Start	10.44	Rating **	A/W	Issue No.	219
LM End	10.44	Issue Type +	Ma	Location *	WS
Category	Earthen Levee			GPS Latitude/Longitude	
				Start	End
Item	Slope Stability			38.570559 °	38.570559 °
				-121.354514 °	-121.354514 °
DWR ID	DWR_NA0001_04_s_2017_219				
Comment Code					
S2 : Repair the levee slope damaged by foot traffic and prevent access where possible.					
Inspector Comment					
The erosion of the levee slope from the footpath appears to be stable at this time and should be monitored.

View of the footpath on the levee slope.

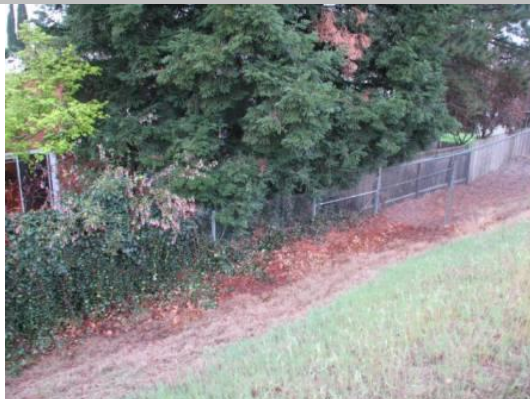
Photo 1 of 1 : FA_2018_NA0001_55_150_20180911_00131.jpg

LM Start	10.49	Rating **	U	Issue No.	150
LM End	10.49	Issue Type +	En	Location *	LS
Category	Earthen Levee			GPS Latitude/Longitude	
				Start	End
Item	Encroachments			38.570095 °	38.570095 °
				-121.353807 °	-121.353807 °
DWR ID	DWR_NA0001_04_s_2012_150				
Comment Code					
FE : Fence					
Inspector Comment					
Wooden privacy fence within 10-ft of levee toe.

03/16/2012 Wood privacy fence completely obstructs access and visibility.

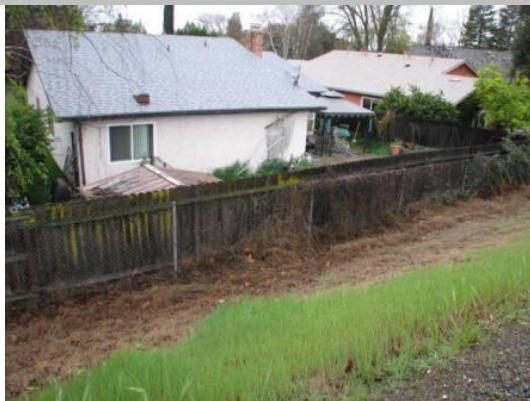
Photo 1 of 1 : FA_2018_NA0001_55_151_20180911_00132.jpg

LM Start	10.51	Rating **	U	Issue No.	151
LM End	10.51	Issue Type +	En	Location *	LS
Category	Earthen Levee			GPS Latitude/Longitude	
				Start	End
Item	Encroachments			38.569921 °	38.569921 °
				-121.353643 °	-121.353643 °
DWR ID	DWR_NA0001_04_s_2012_151				
Comment Code					
FE : Fence					
Inspector Comment					
Wooden privacy fence within 10-ft of levee toe.

03/16/2012 Wood privacy fence completely obstructs access and visibility.

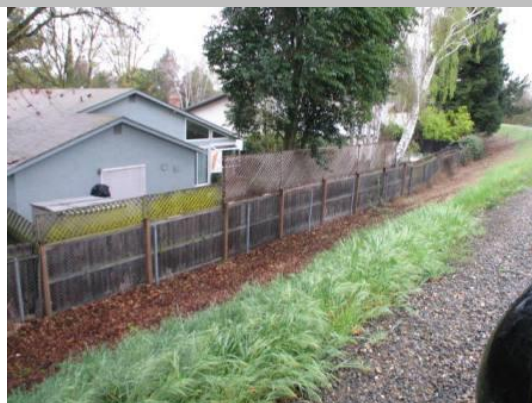
Photo 1 of 1 : FA_2018_NA0001_55_152_20180911_00133.jpg

LM Start	10.52	Rating **	U	Issue No.	152
LM End	10.52	Issue Type +	En	Location *	LS
Category	Earthen Levee			GPS Latitude/Longitude	
				Start	End
Item	Encroachments			38.569758 °	38.569758 °
				-121.353535 °	-121.353535 °
DWR ID	DWR_NA0001_04_s_2012_152				
Comment Code					
FE : Fence					
Inspector Comment					
Wooden privacy fence within 10-ft of levee toe.

03/16/2012 Wood privacy fence completely obstructs access and visibility.

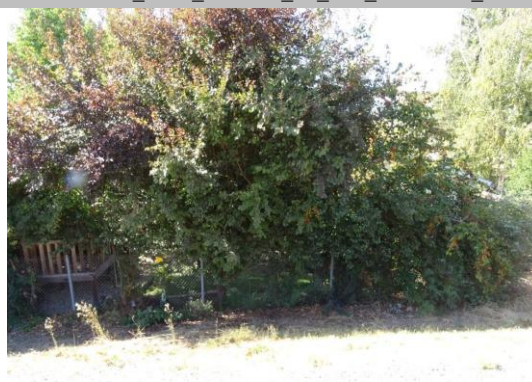
Photo 1 of 1 : FA_2018_NA0001_55_217_20181024_00269.jpg

LM Start	10.56	Rating **	M	Issue No.	217
LM End	10.56	Issue Type +	En	Location *	LS
Category	Earthen Levee			GPS Latitude/Longitude	
				Start	End
Item	Vegetation			38.569296 °	38.569296 °
				-121.353365 °	-121.353365 °
DWR ID	DWR_NA0001_04_f_2018_217				
Comment Code					
V6 : Landscaping					
Inspector Comment					
Trees and bushes block visibility of levee toe.

View of landowner vegetation blocking visibility of levee toe. Fall 2018

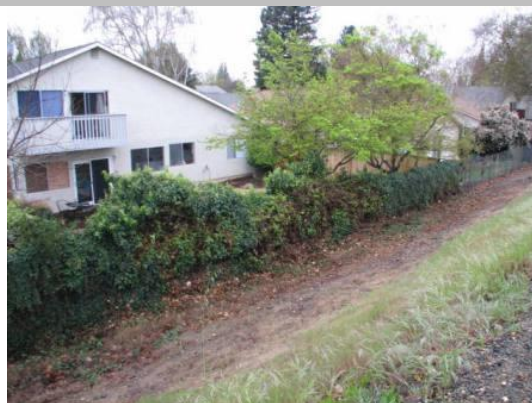
Photo 1 of 1 : FA_2018_NA0001_55_153_20180911_00134.jpg

LM Start	10.57	Rating **	U	Issue No.	153
LM End	10.57	Issue Type +	En	Location *	LS
Category	Earthen Levee			GPS Latitude/Longitude	
				Start	End
Item	Encroachments			38.569166°	38.569166°
				-121.353272°	-121.353272°
DWR ID	DWR_NA0001_04_s_2012_153				
Comment Code					
FE : Fence					
Inspector Comment					
Wooden privacy fence and ivy within 10-ft of levee toe.

03/16/2012 Wood privacy fence completely obstructs access and visibility.
